AFRPL-TR-70-43

**LONG-TERM STORABILITY
OF
PROPELLANT TANKAGE AND COMPONENTS
INTERIM REPORT #1**

R. B. MEARS, 1st LIEUTENANT, USAF

MAY 1970

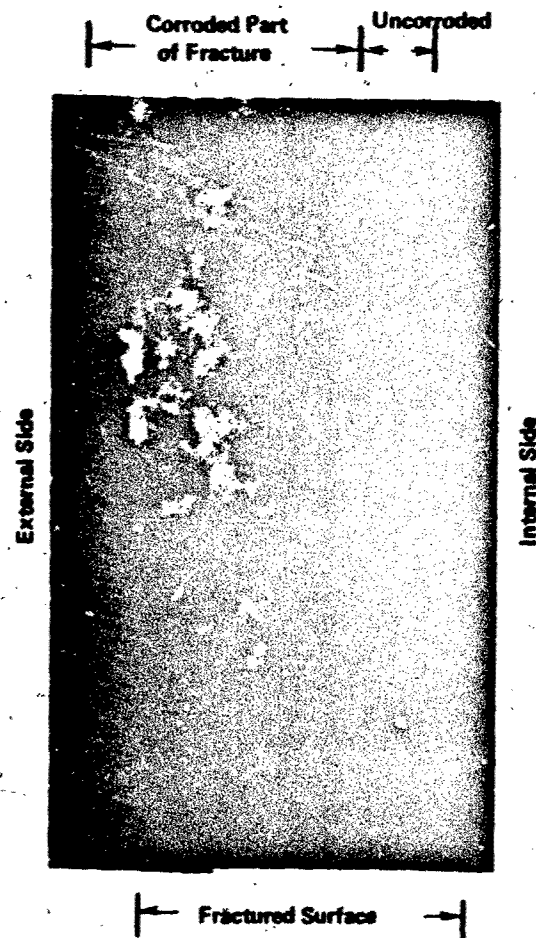
Figure 7. Edge View of Crack Through Thickness of Material Showing Corrosion Progressing from External (Left Side) to Internal (Right Side) Surface.

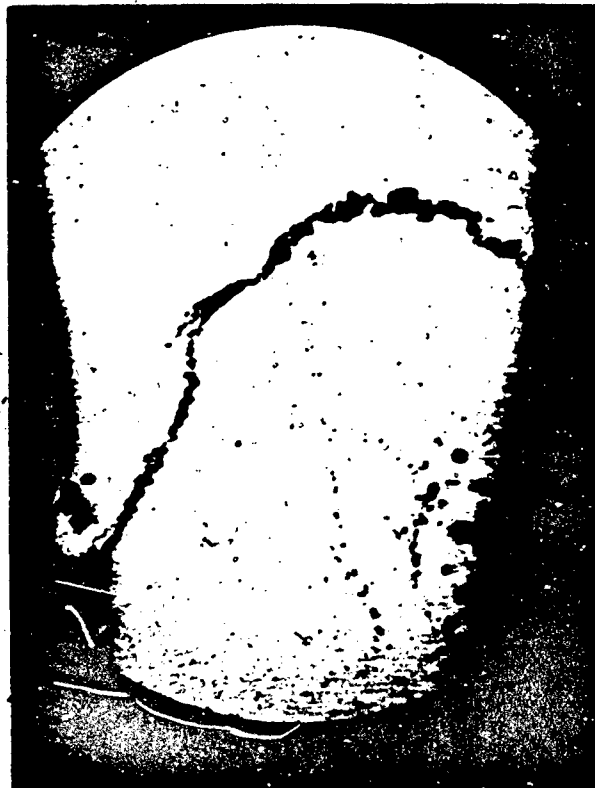
Figure 8. Stress Corrosion Crack of Primary Leak Area (ref Fig. 1).

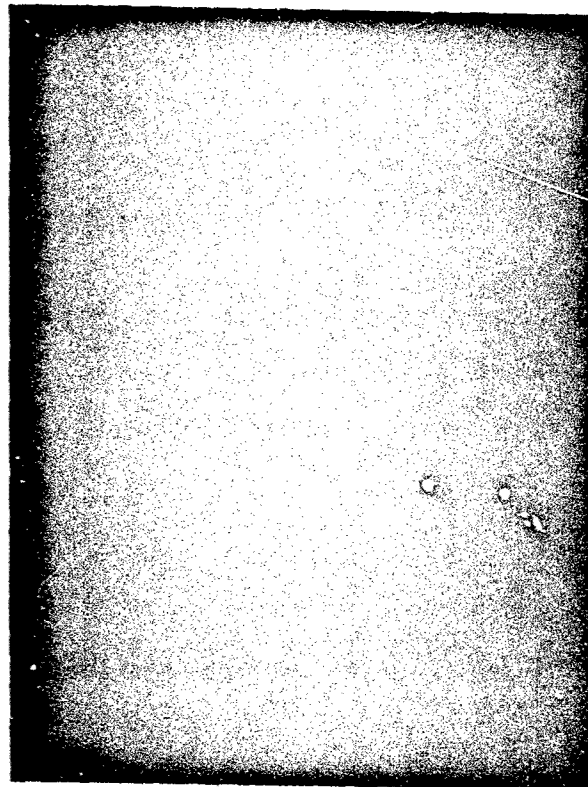
Figure 9. Same crack as in Figure 8.

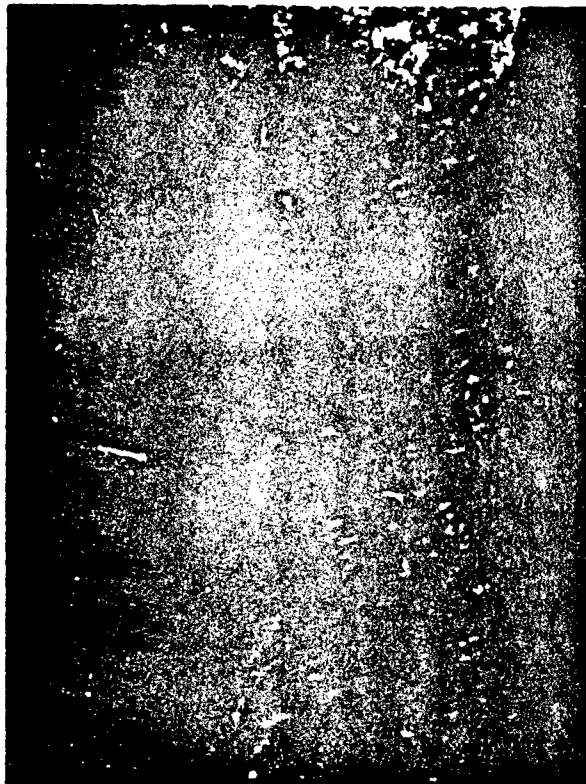
Figure 10. Exfoliation Corrosion
